Manhole Inspection Summary

Manhole # S15C1_021MH

Location Address: **1701 HERKIMER ST** Cross Street: **INVERNESS AV**

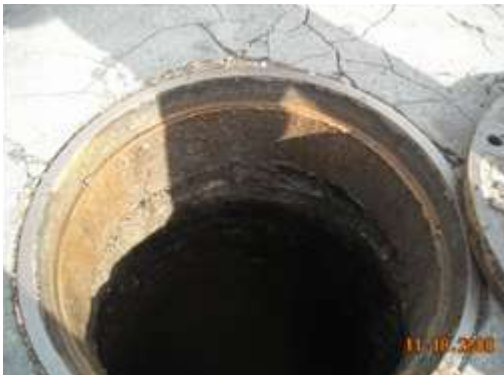
Defect

Frame Offset: **0** (in.) Condition: ☐ Sound ☐ Cracked ☒ **Leaks**

INFLOW EVIDENCE FROM SHEETING

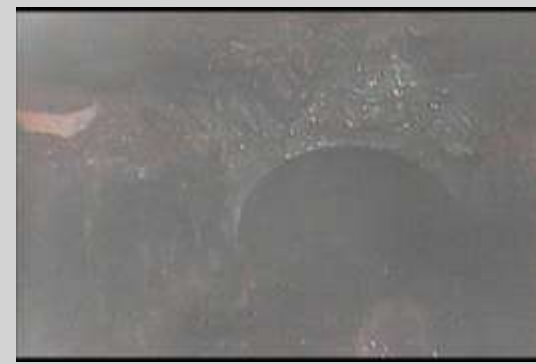
12 O'Clock Outflow

8 in. Circular Gravity Sewer
Pipe Out @ 12 O'Clock

Pipe Height: **8.4** (in.) Rod and Bar (Angled)
Pipe Material: **Clay** ☐ Pipe Lined
Invert Depth: **11.38** (ft.) Flow Characteristics: **Fast**
Deposits: ☒ None ☐ Mud ☐ Sludge ☐ Debris ☐ Grease
Silt Depth: **0** (in.) Deposits Extent:
Infiltration: **None** Pipe Seal Cond: **Unknown**

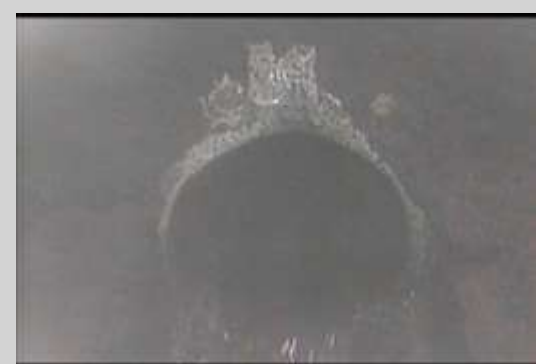
3 O'Clock Inflow

8 in. Circular Gravity Sewer
Pipe In @ 3 O'Clock

Pipe Height: **8.4** (in.) Rod and Bar (Angled)
Pipe Material: **Clay** ☐ Pipe Lined
Invert Depth: **10.83** (ft.) Flow Characteristics: **Fast**
Deposits: ☒ None ☐ Mud ☐ Sludge ☐ Debris ☐ Grease
Silt Depth: **0** (in.) Deposits Extent:
Infiltration: **None** Pipe Seal Cond: **Sound**
